Manhole Inspection Summary

Manhole # S41QQ_015MH

Insp Date: **2/20/07 11:34 AM**

Location Address: **2536 AISQUITH ST**

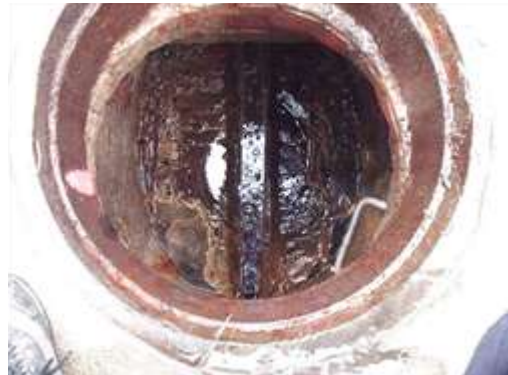
Top View

Frame leaks. Frame offset. Adjustment deterioration and infiltration. Bench debris.

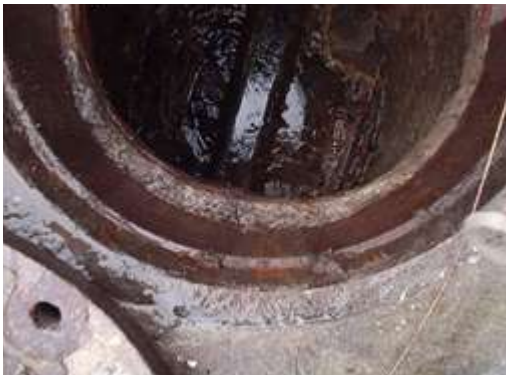
Defect

Frame leaks. Frame offset. Adjustment deterioration and infiltration.

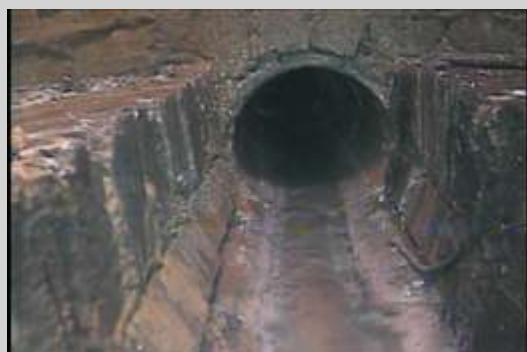
Pipe Out @ 12 O'Clock

8 in. Circular Gravity Sewer

Pipe Material: **Clay** ☐ Pipe Lined

Invert Depth: **6.57** (ft.) Flow Characteristics: **Slow**

Infiltration: **None** Pipe Seal Cond: **Unknown**

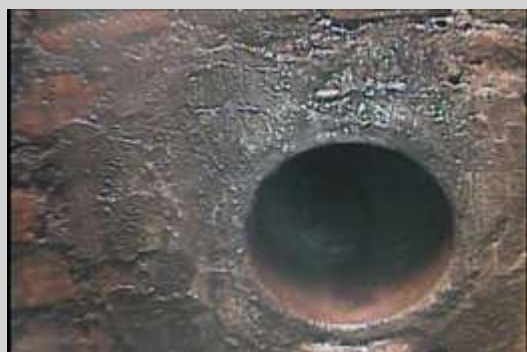
Pipe In @ 3 O'Clock

4 in. Circular Gravity Sewer

Pipe Material: **Clay** ☐ Pipe Lined

Invert Depth: **4.36** (ft.) Flow Characteristics: **None**

Connects To: **House connection / Service line**

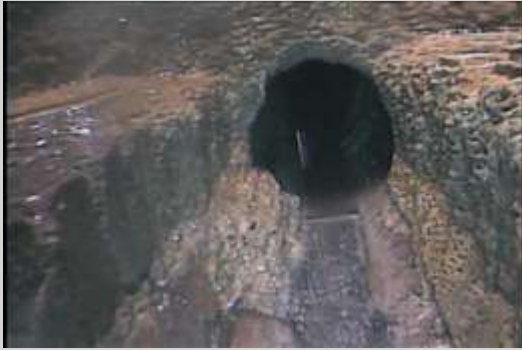
Pipe In @ 6 O'Clock

8 in. Circular Gravity Sewer

Deposits: ☐ None ☐ Mud ☐ Sludge ☒ **Debris** ☐ Grease

Deposits Extent: **Light**
